Client: -  
Contractor: -  
Subcontractor: -  
Location: -  
Object: Jacket (X-knot)  
Operating conditions: Offshore  
Year of application: December 2012  
New coating system: Stopaq Wrappingband CZH + Stopaq Intermediate PVC + Stopaq Outerglass Shield XT  
Reason: Failure of existing coating

Case Study – Pluto LNG platform jacket

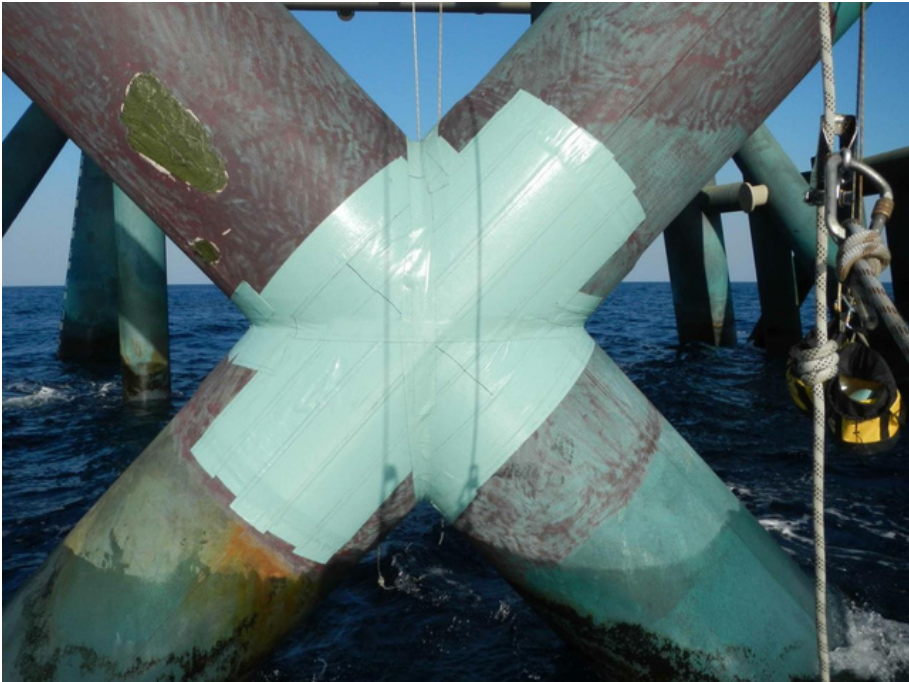
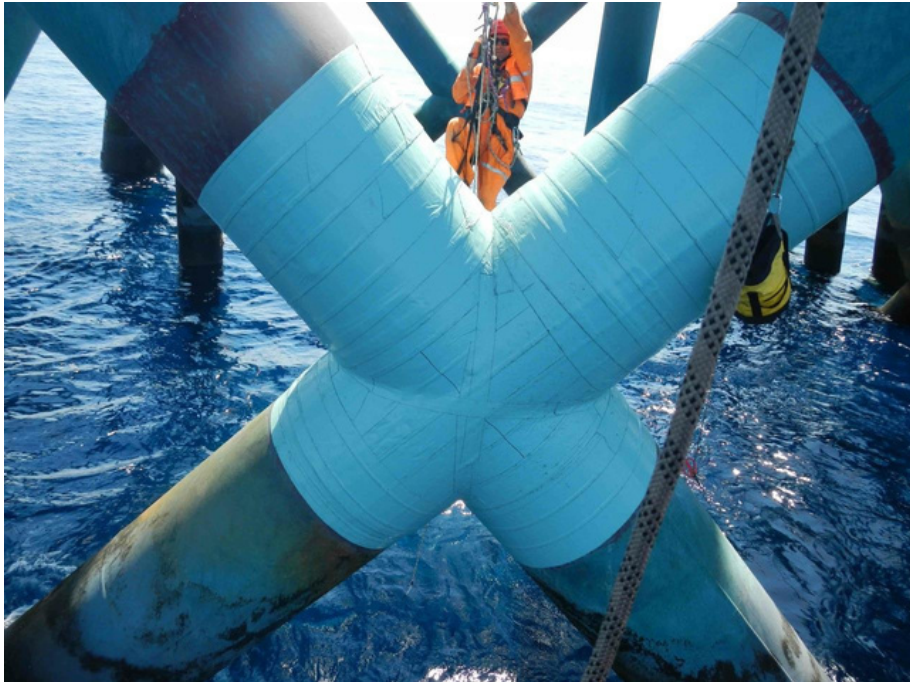
*After surface preparation, the corrosion prevention layer, the Wrappingband CZH is applied*

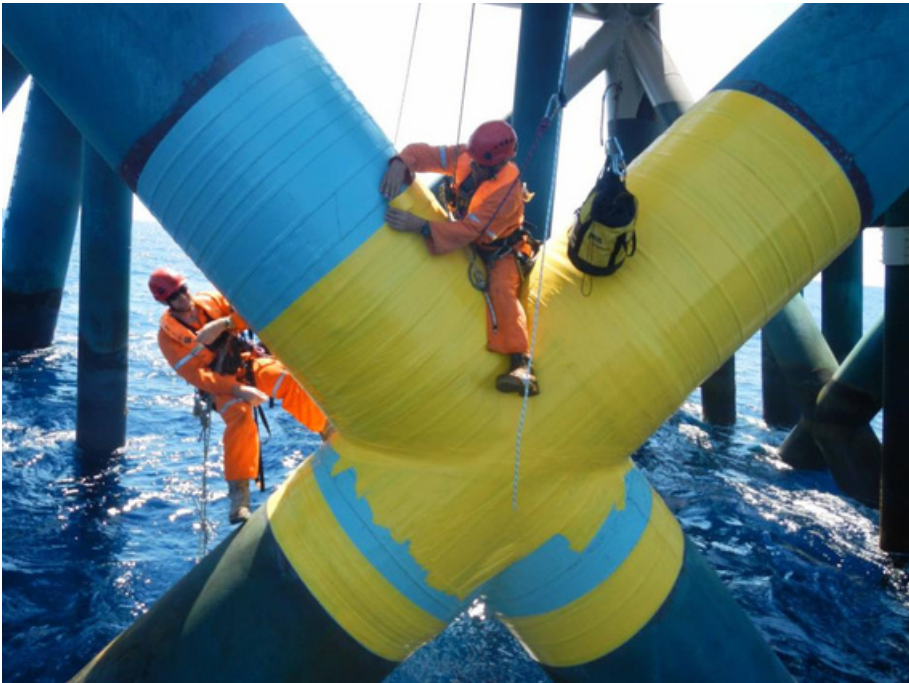
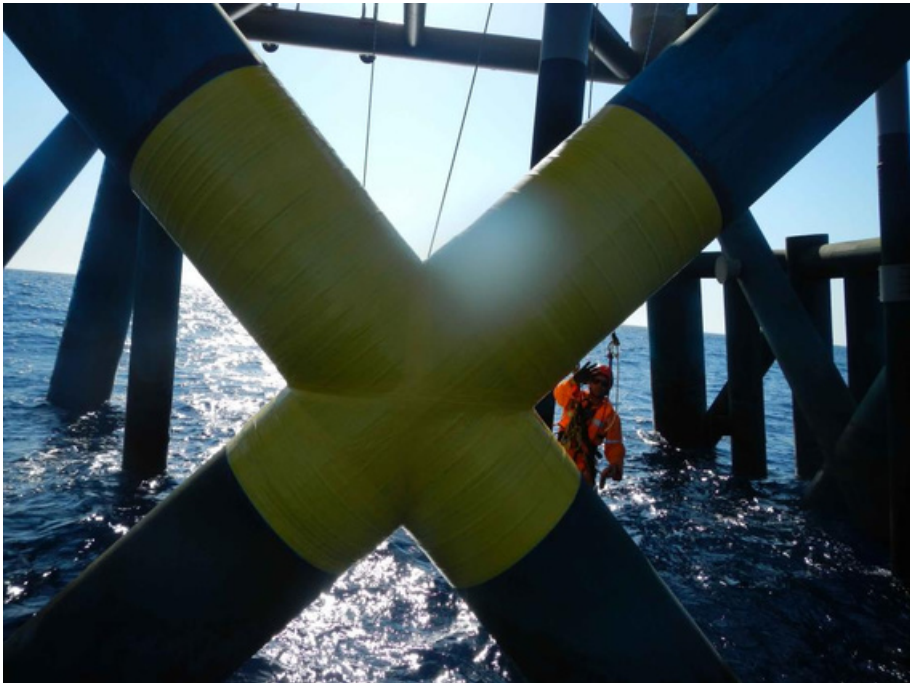
*Application of the Intermediate Wrap PVC after the Wrappingband CZH application*

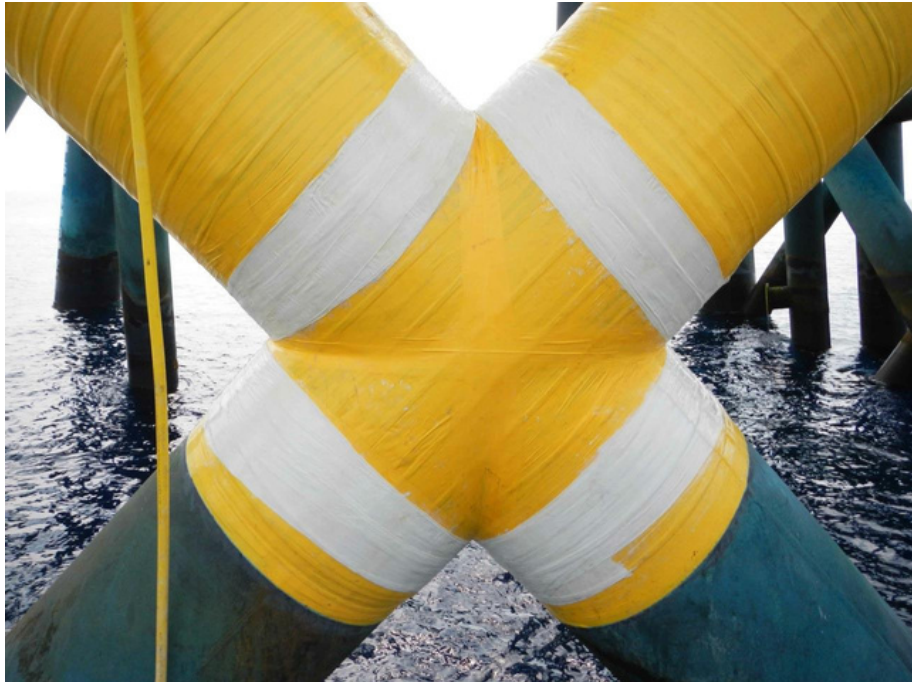
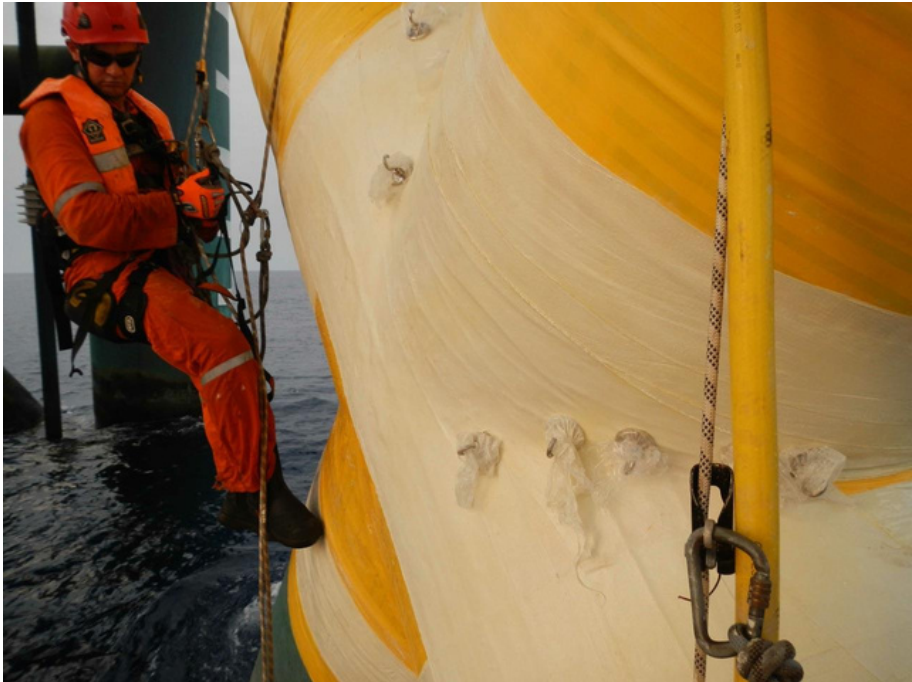
*The Stopaq Outerglass Shield XT is applied for extra mechanical protection*
